Manhole Inspection Summary

Manhole # **S17A__004MH**

Insp Date: **11/20/07 1:40 PM**

Location Address: **800 BENTALOU ST**

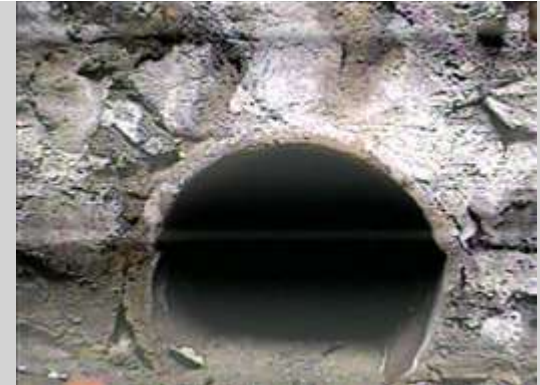
12 O'Clock Outflow

8 in. Circular Gravity Sewer
Pipe Out @ 12 O'Clock

Pipe Material: **Clay** ☐ Pipe Lined

Invert Depth: **4.35** (ft.) Flow Characteristics: **None**

Deposits: ☒ None ☐ Mud ☐ Sludge ☐ Debris ☐ Grease

Infiltration: **None** Pipe Seal Cond: **Sound**
